Project/Site: STH 59 West Bypass City/County: City and Town of Waukesha, Waukesha County Sampling Date: 09/08/2011
 Applicant/Owner: _____ State: WI Sampling Point: 56
 Investigator(s): Donald M. Reed, PhD., SEWRPC Section, Township, Range: SE 1/4 Section 31, T7N, R19E
 Landform (hillslope, terrace, etc.): low terrace Local relief (concave, convex, none): none
 Slope (%): 0-2% Lat: _____ Long: _____ Datum: _____
 Soil Map Unit Name: Pella silt loam (Ph) Pd NWI classification: E2K
 Are climatic/hydrologic conditions on the site typical for this time of year? Yes ☒ No ☐ (If no, explain in Remarks)
 Are Vegetation _____, Soil _____, or Hydrology _____ significantly disturbed? Are "Normal Circumstances" present? Yes ☐ No ☐
 Are Vegetation _____, Soil _____, or Hydrology _____ naturally problematic? (If needed, explain any answers in Remarks.)

Proposed Waukesha West Bypass
Sections 5, 6, 7, 8 and 17, T06N-R19E
Sections 29, 30, 31 and 32, T07N-R19E
City and Town of Waukesha and City of Pewaukee, Waukesha County

Subsurface Exploration and Geotechnical Evaluation, Summit Road to Genesee Road Alternative Alignments – Waukesha West Bypass

PREPARED FOR: Waukesha County

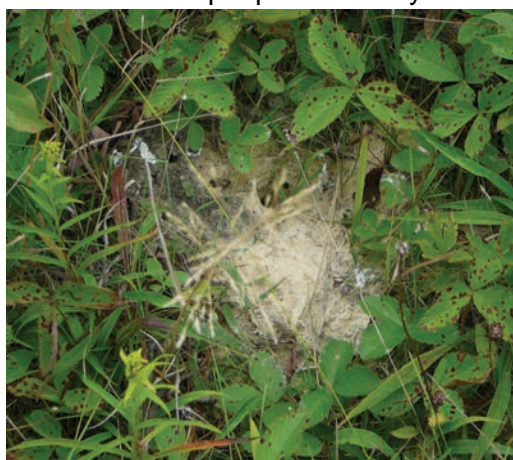
Photo 18: Sample point 18 crayfish holes

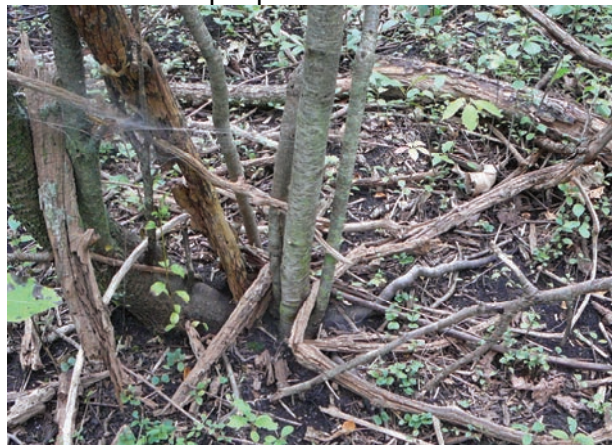
Photo 23: Sample point 22 shallow roots

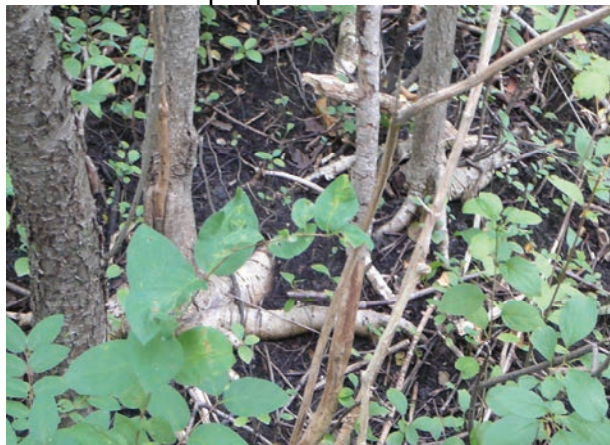
Photo 24: Sample point 22 shallow roots

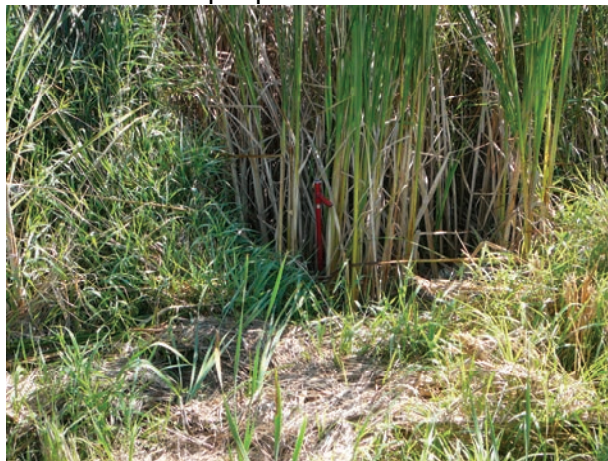
Photo 58: Sample point 55

Remarks: (include photo number here or on a separate sheet.) Shallow marsh. Photo 58.

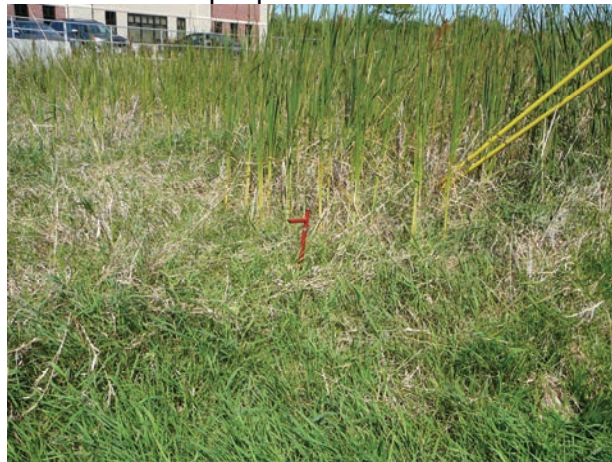
Photo 59: Sample point 56

2. _____	_____	<input type="checkbox"/>	_____	
3. _____	_____	<input type="checkbox"/>	_____	
4. _____	_____	<input type="checkbox"/>	_____	
	<u>0</u>	= Total Cover		
				Hydrophytic Vegetation Present? Yes <input checked="" type="checkbox"/> No <input type="checkbox"/>
Remarks: (include photo number here or on a separate sheet.) Fresh (wet) meadow. Photo 59.

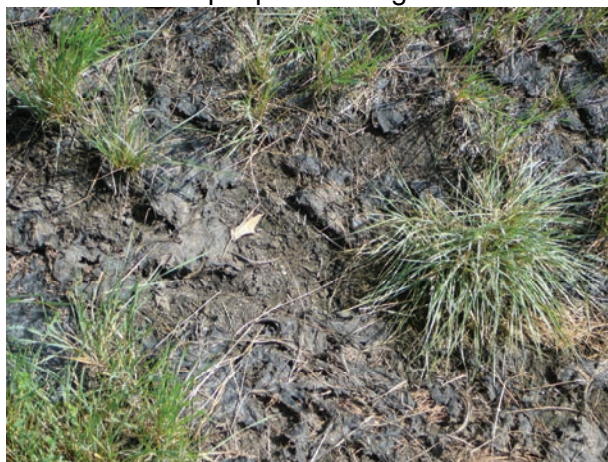
| <input checked="" type="checkbox"/> Algal Mat or Crust (B4) PHOTOS 60, 61 | <input type="checkbox"/> Recent Iron Reduction in Tilled Soils (C6) |

Remarks: Site is a constructed drainage ditch. Photos 60 and 61.

Photo 60: Sample point 57 algae crust

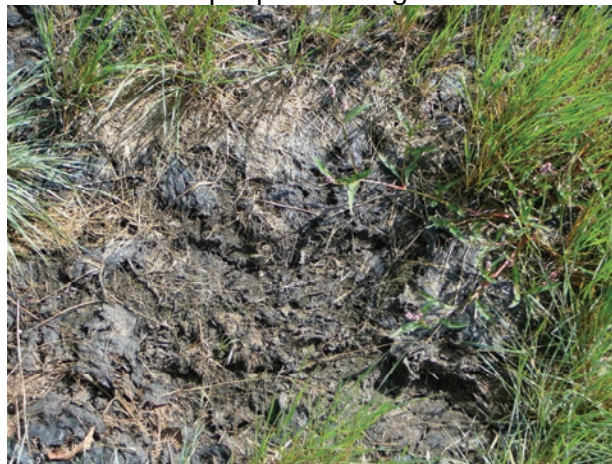
Photo 61: Sample point 57 algae crust

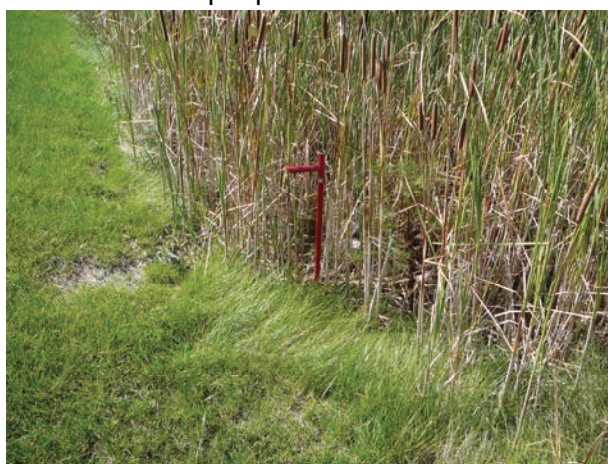
Photo 62: Sample point 57

1. _____	_____	<input type="checkbox"/>	_____	
2. _____	_____	<input type="checkbox"/>	_____	
3. _____	_____	<input type="checkbox"/>	_____	
4. _____	_____	<input type="checkbox"/>	_____	
	<u>0</u>	= Total Cover		
Remarks: (include photo number here or on a separate sheet.) Shallow marsh. Photo 62.

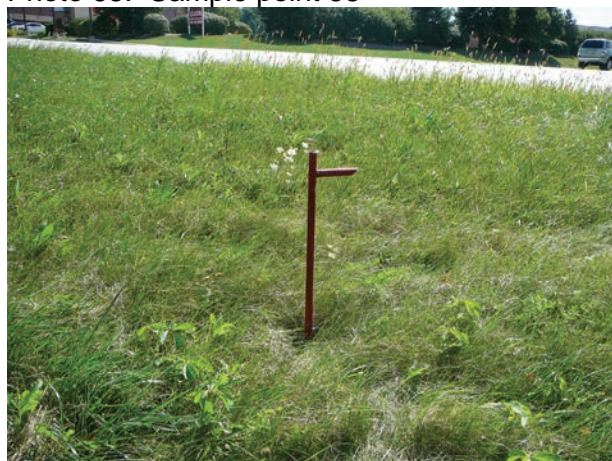
Photo 63: Sample point 58

2. _____	_____	<input type="checkbox"/>	_____	
3. _____	_____	<input type="checkbox"/>	_____	
4. _____	_____	<input type="checkbox"/>	_____	
	<u>0</u>	= Total Cover		
				Hydrophytic Vegetation Present? Yes <input checked="" type="checkbox"/> No <input type="checkbox"/>
Remarks: (include photo number here or on a separate sheet.) Mowed lawn. Photo 63.

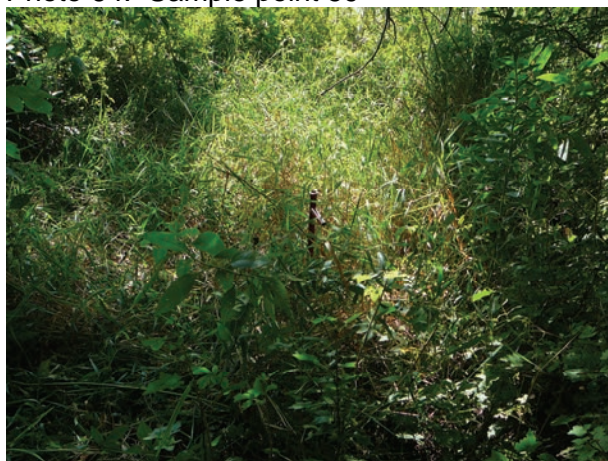
Photo 64: Sample point 59

Remarks: (include photo number here or on a separate sheet.) Fresh (wet) meadow and lowland hardwoods. Photo.64.

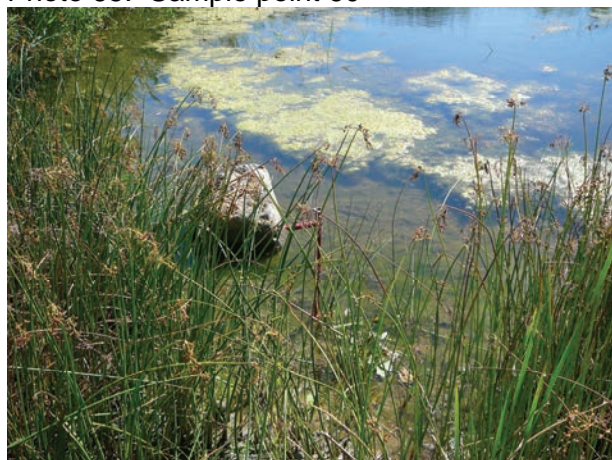
Photo 65: Sample point 60

2. _____	_____	<input type="checkbox"/>	_____	
3. _____	_____	<input type="checkbox"/>	_____	
4. _____	_____	<input type="checkbox"/>	_____	
	<u>0</u>	= Total Cover		
				Hydrophytic Vegetation Present? Yes <input checked="" type="checkbox"/> No <input type="checkbox"/>
Remarks: (include photo number here or on a separate sheet.) * Chara (moss) sp. covers 33% of sample area substrate. Stormwater detention pond with shallow marsh along the edge. Photo 65.

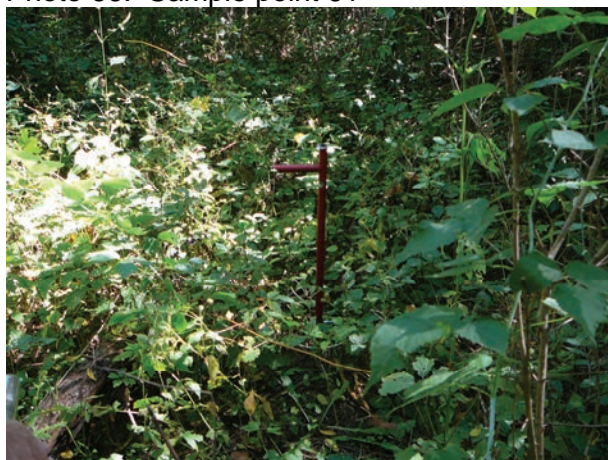
Photo 66: Sample point 61

2. <u>Parthenocissus quinquefolia</u>	3	<input type="checkbox"/>	FACU		
3. _____	_____	<input type="checkbox"/>	_____		
4. _____	_____	<input type="checkbox"/>	_____		
	18	= Total Cover			
Remarks: (include photo number here or on a separate sheet.) * Other NON-dominant herbs include: Arisaema triphyllum (1%) FACW and Aster lateriflorus (1%) FACW. Upland hardwoods and buckthorn thicket. Photo 66.

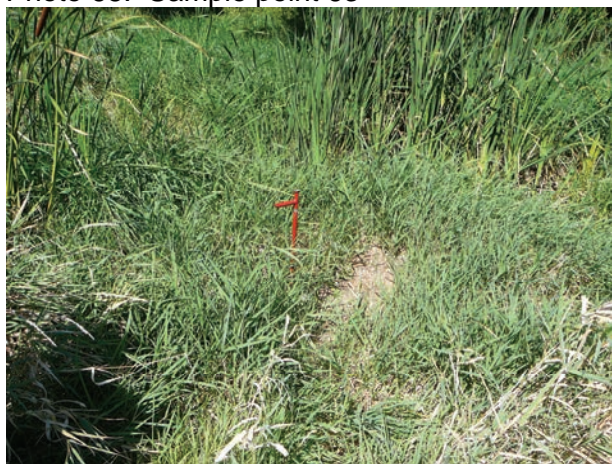
Photo 68: Sample point 63

1. _____	_____	<input type="checkbox"/>	_____	
2. _____	_____	<input type="checkbox"/>	_____	
3. _____	_____	<input type="checkbox"/>	_____	
4. _____	_____	<input type="checkbox"/>	_____	
	<u>0</u>	= Total Cover		Definitions of Vegetation Strata: Tree – Woody plants 3in. (7.6 cm) or more in diameter at breast height (DBH), regardless of height Sapling/shrub – Woody plants less than 3in. DBH and greater than 3.28 ft (1 m) tall. Herb – All herbaceous (non-woody) plants, regardless of size, and woody plants less than 3.28 ft tall. Woody vines – All woody vines greater than 3.28 ft in height
				Hydrophytic Vegetation Present? Yes <input checked="" type="checkbox"/> No <input type="checkbox"/>
Remarks: (include photo number here or on a separate sheet.) Fresh (wet) meadow. Photo 68.

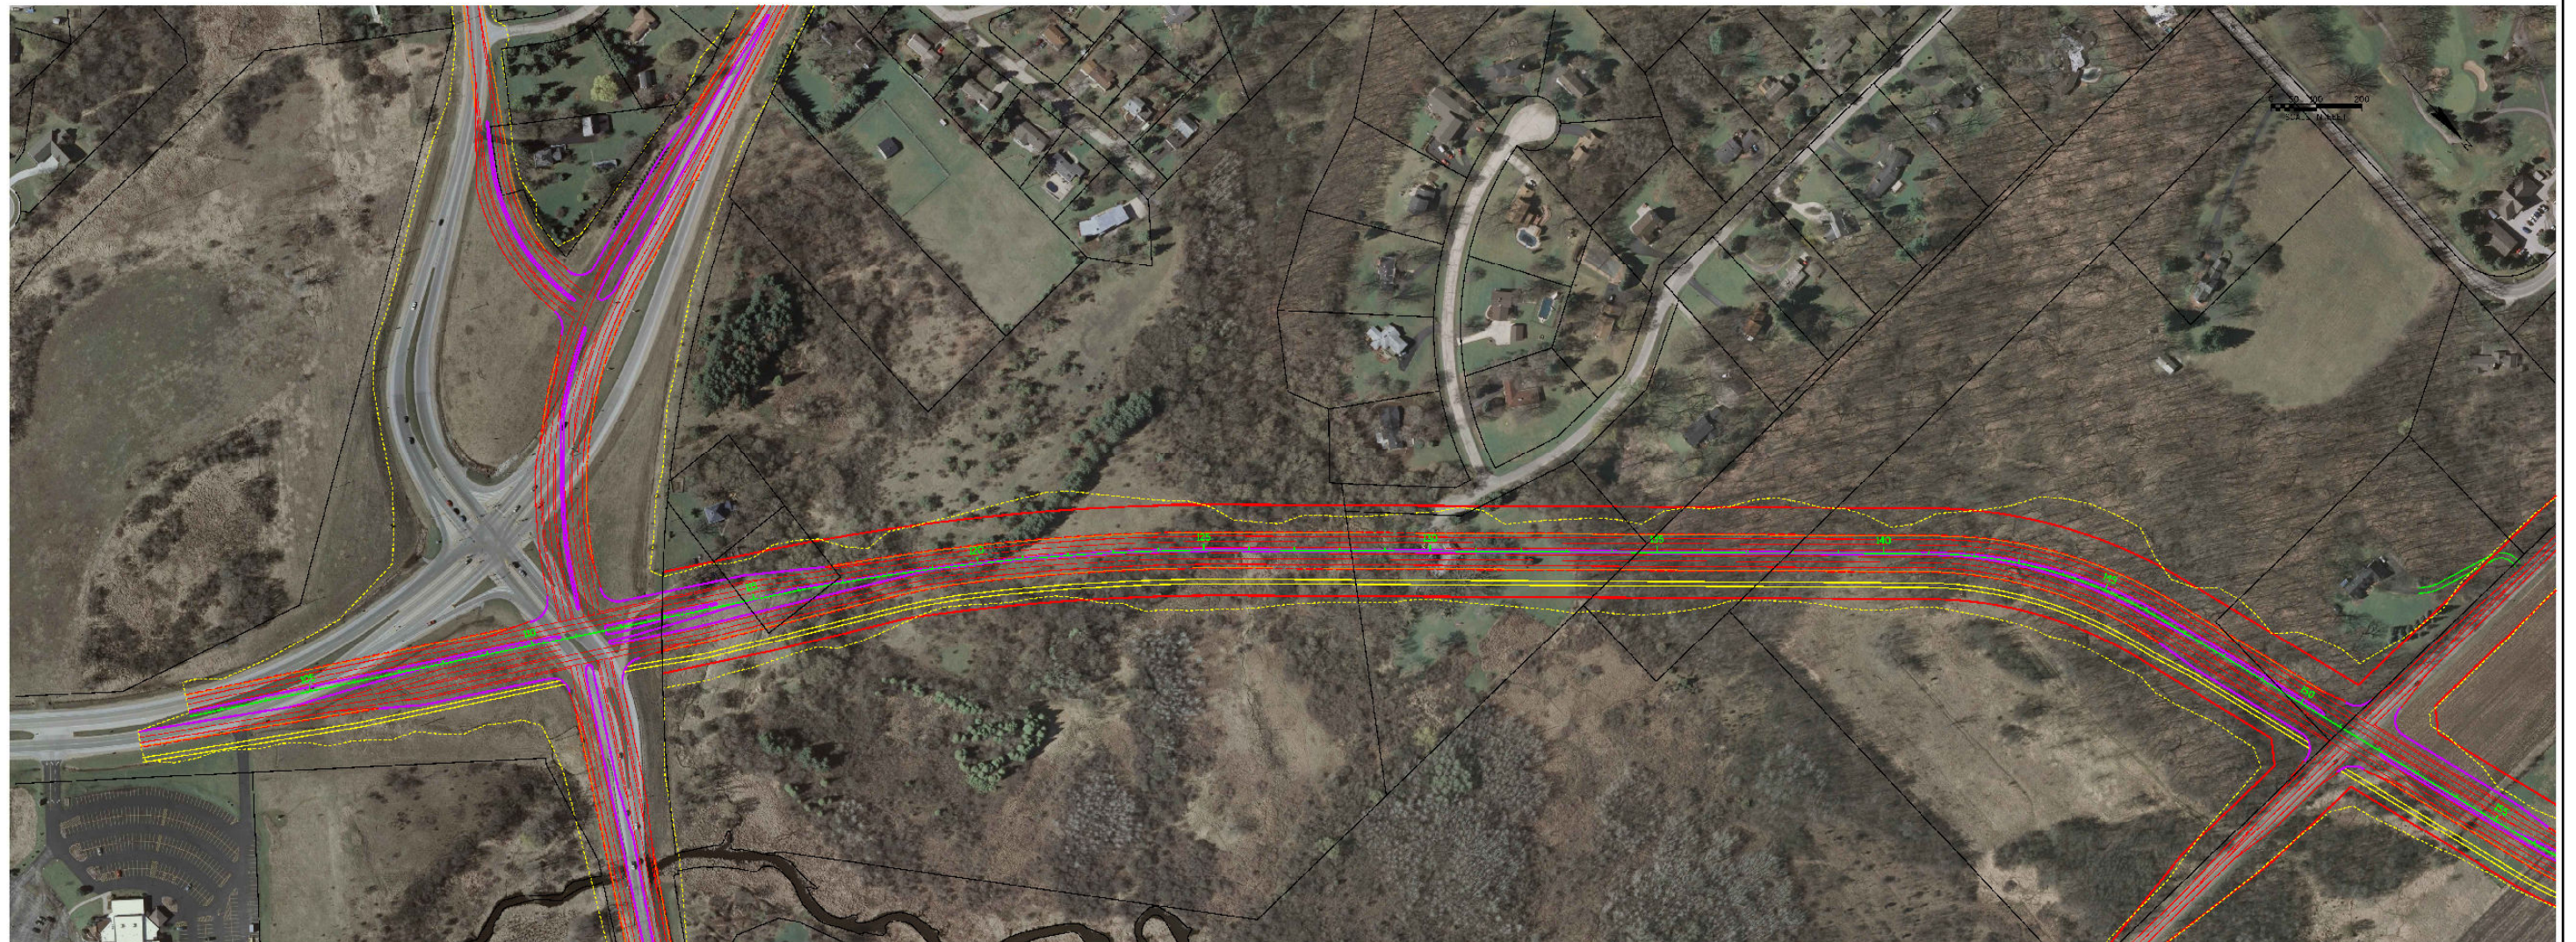
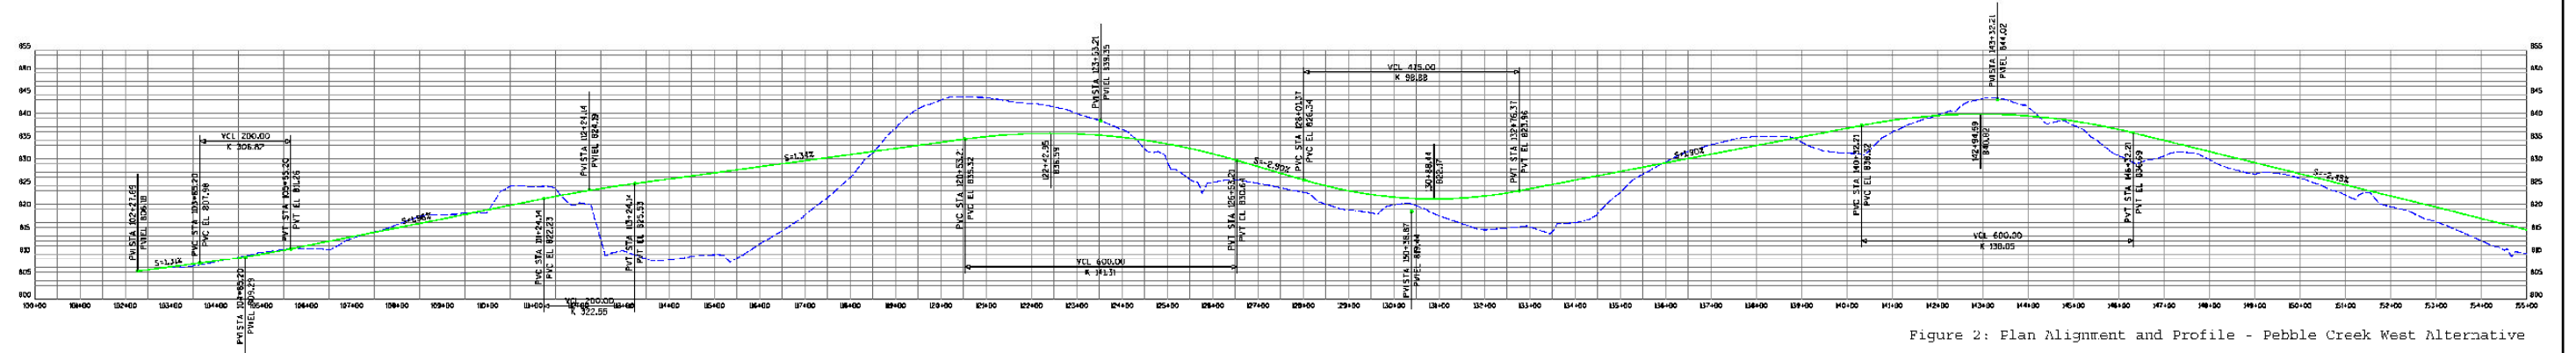
Figure 2: Plan Alignment and Profile - Pebble Creek West Alternative

Figure 2 - Plan Alignment and Profile
Pebble Creek West Alternative
Waukesha West Bypass
July 2011

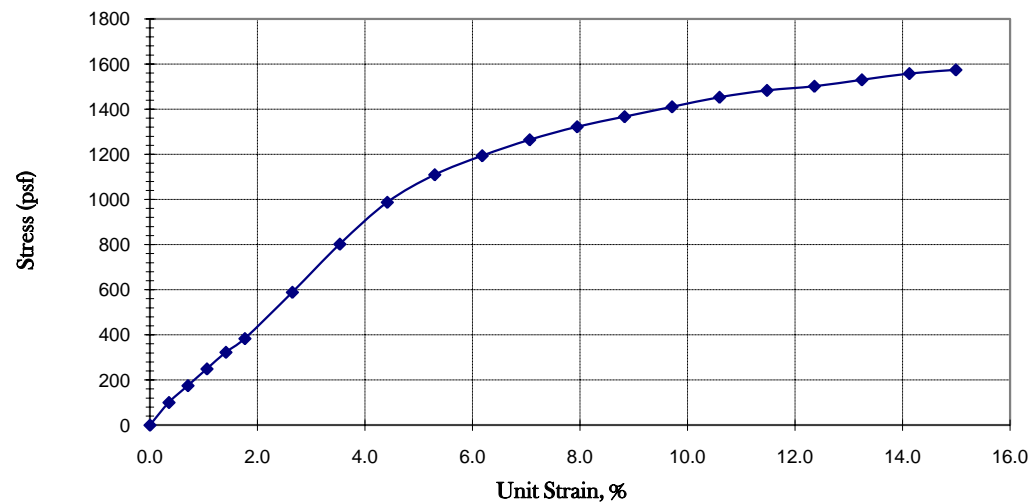
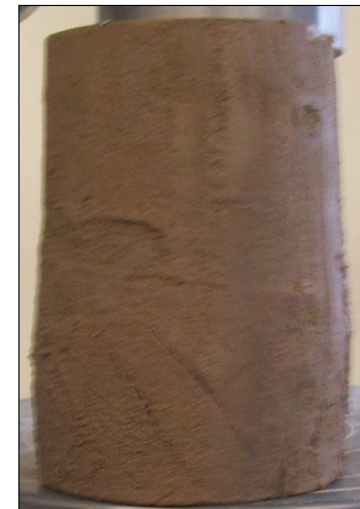
Boring no.: 2011-1 Diameter (in) 2.81
Sample no.: 2 Area (sq. in.): 6.19
Depth of Soil: 2-4' Height: (in.): 5.66
Description of Soil: LEAN CLAY, gray to green with yellow mottling, wet
Strain Rate (in/min): 0.042

UC Strength, Q_u (tsf) 0.79
Wet Density (pcf) 126.8
Dry Density (pcf) 102.4
Moisture Content (%) 23.8

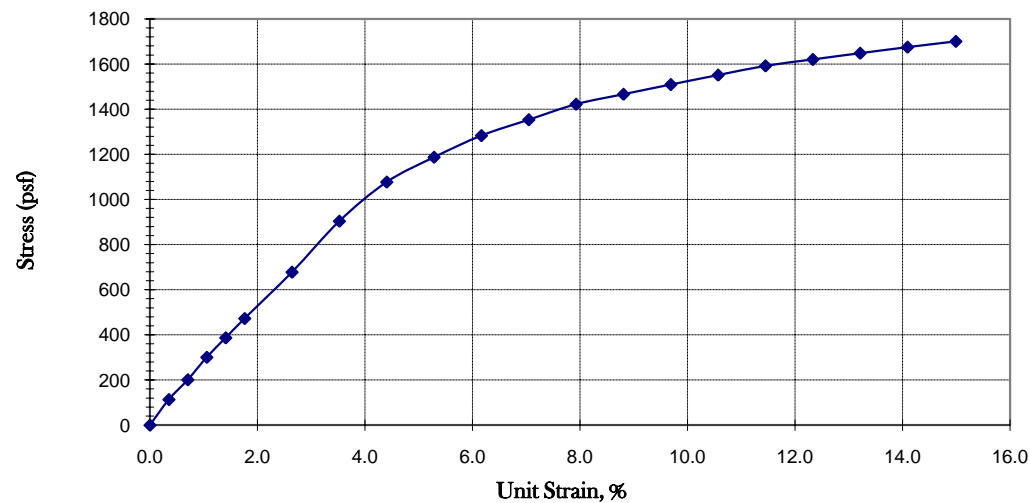
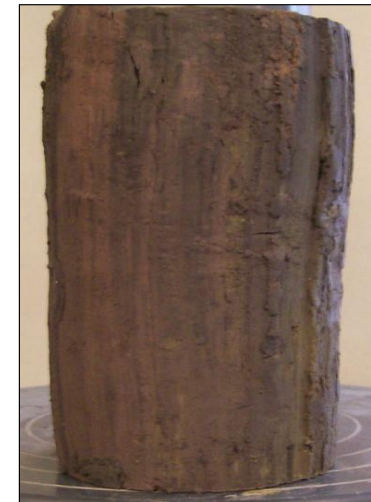
Boring no.: 2011-2 Diameter (in) 2.80
Sample no.: 2 Area (sq. in.): 6.16
Depth of Soil: 2-4' Height: (in.): 5.68
Description of Soil: LEAN CLAY, gray to green with yellow mottling, wet
Strain Rate (in/min): 0.042

UC Strength, Q_u (tsf) 0.85
Wet Density (pcf) 124.5
Dry Density (pcf) 91.1
Moisture Content (%) 36.7

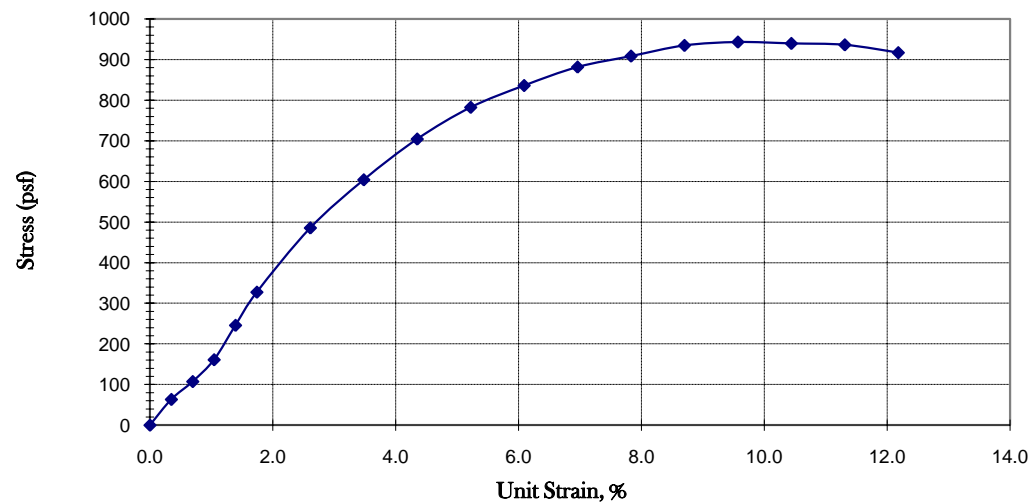
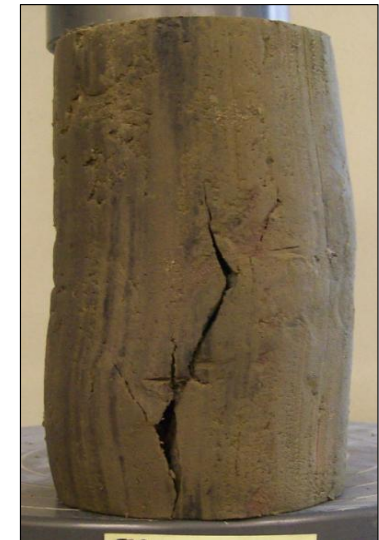
Boring no.: 2011-3 Diameter (in) 2.79
Sample no.: 2 Area (sq. in.): 6.13
Depth of Soil: 2'-4' Height (in.): 5.75
Description of Soil: LEAN CLAY, with silt and sand pockets, blueish gray with brown mottling, moist
Strain Rate (in/min): 0.042

UC Strength, Q_u (tsf)	0.47
Wet Density (pcf)	135.8
Dry Density (pcf)	114.5
Moisture Content (%)	18.6

Remarks Sample displayed one significant vertical shear fracture. $Q_p = 0.25 - 0.75$

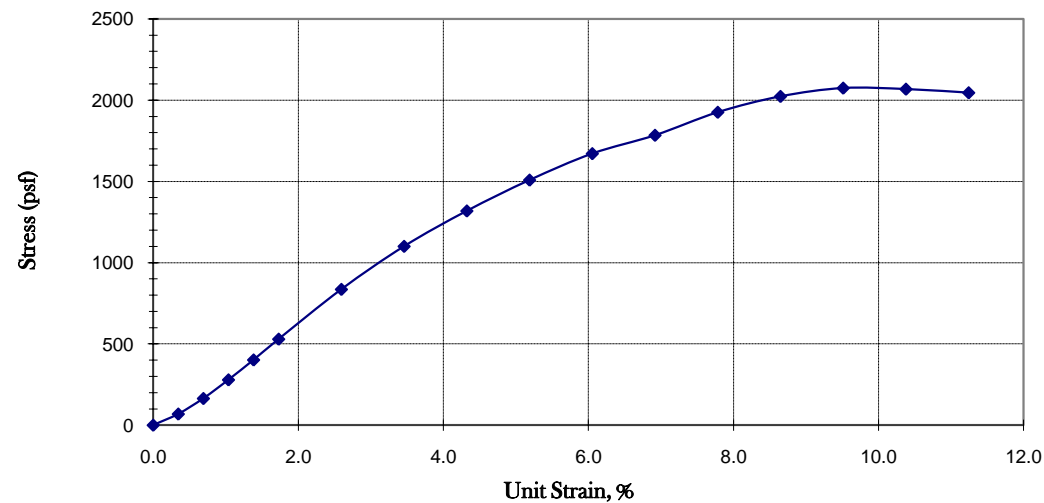
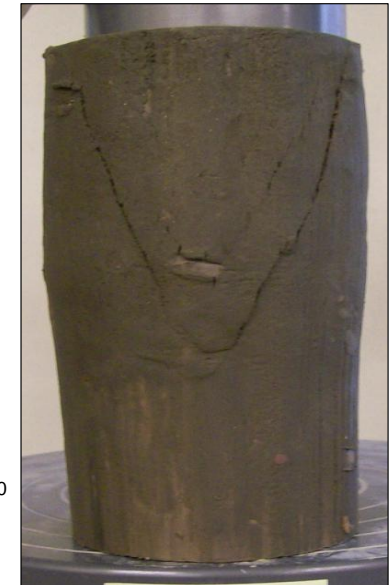
Boring no.: 2011-5 Diameter (in): 2.82
Sample no.: 2 Area (sq. in.): 6.22
Depth of Soil: 2'-4' Height (in.): 5.78
Description of Soil: LEAN CLAY, gray to reddish brown/ rusty brown, moist
Strain Rate (in/min): 0.042

UC Strength, Q_u (tsf) 1.04
Wet Density (pcf) 134.2
Dry Density (pcf) 111.9
Moisture Content (%) 19.9

Remarks Sample displayed one significant "v" shaped fracture. $Q_p = 0.5 - 1.0$

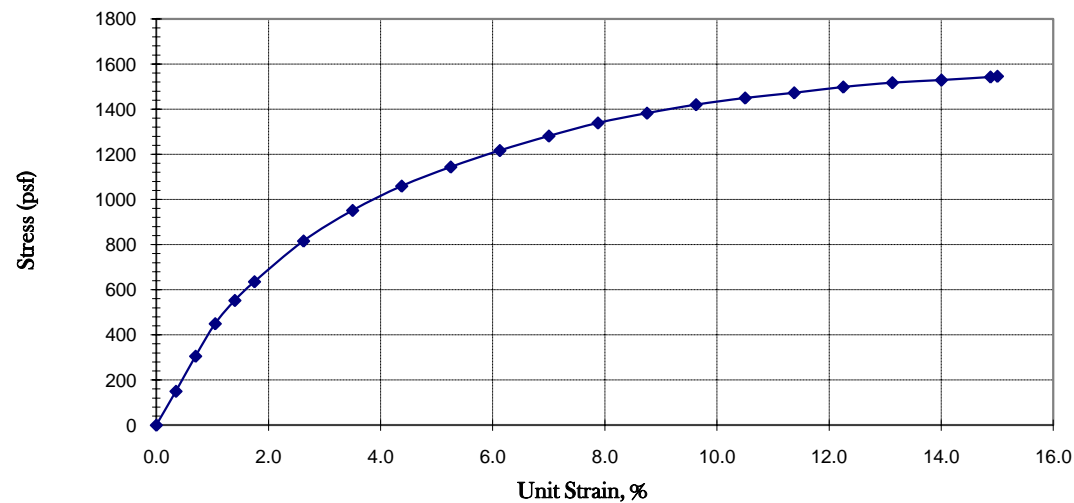
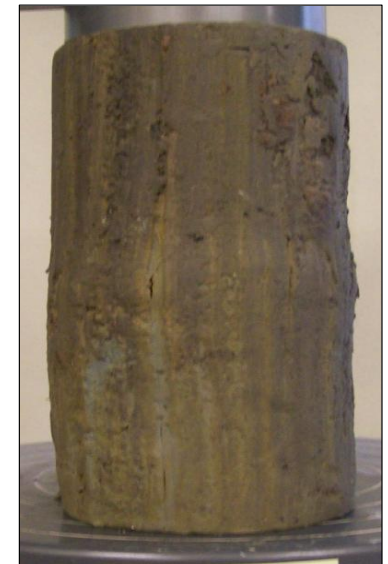
Boring no.: 2011-9 Diameter (in) 2.75
Sample no.: 2 Area (sq. in.): 5.96
Depth of Soil: 2'-4' Height: (in.): 5.71
Description of Soil: LEAN CLAY, dark brown and blueish gray, moist
Strain Rate (in/min): 0.042

UC Strength, Q_u (tsf) 0.77
Wet Density (pcf) 125.6
Dry Density (pcf) 96.8
Moisture Content (%) 29.8

Remarks Sample displayed minimal signs of shear stress. $Q_p = 0.5 - 1.0$

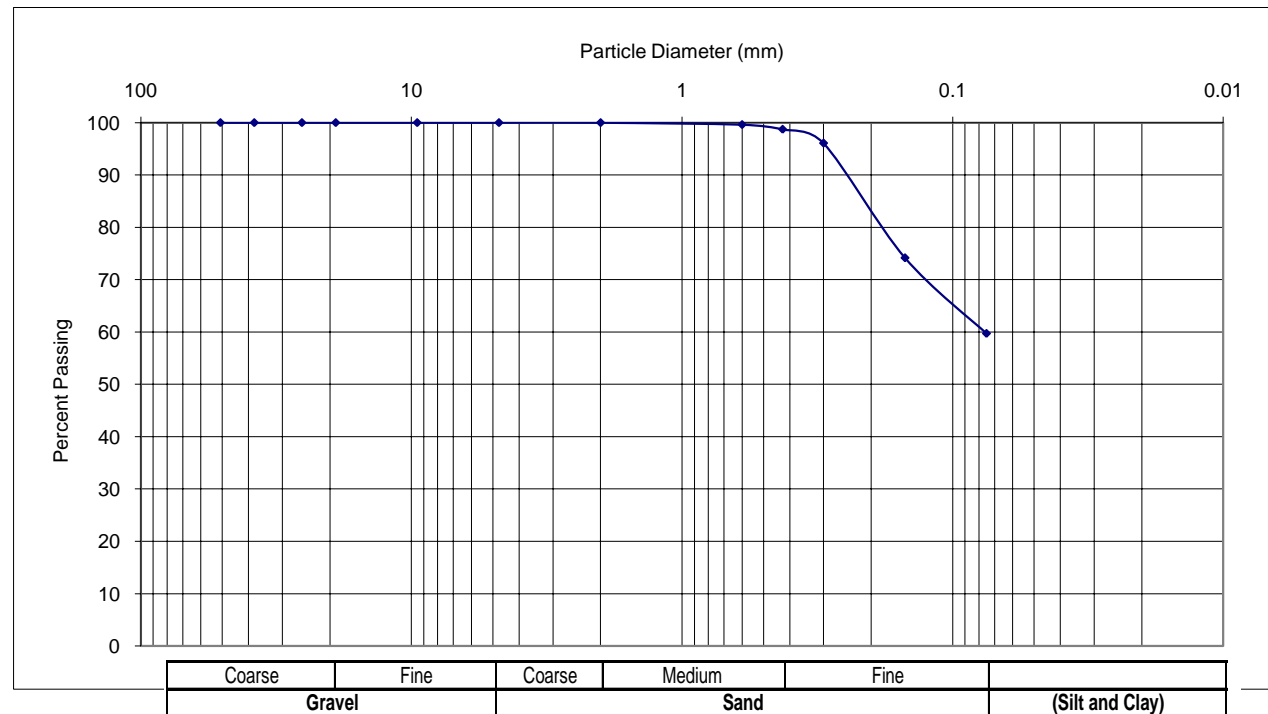
Sieve	Sieve Opening (mm)	Percent Passing (%)
2 in.	50.8	100
1 1/2 in.	38.1	100
1 in.	25.4	100
3/4 in.	19.05	100
3/8 in.	9.525	100
#4	4.75	100
#10	2	100
#30	0.6	100
#40	0.425	98.7
#50	0.3	96.1
#100	0.15	74.2
#200	0.075	59.7

Remarks: Gravel 0.0 % Sand 40.3 %
Passing #200 Sieve (Silt & Clay) 59.7 %

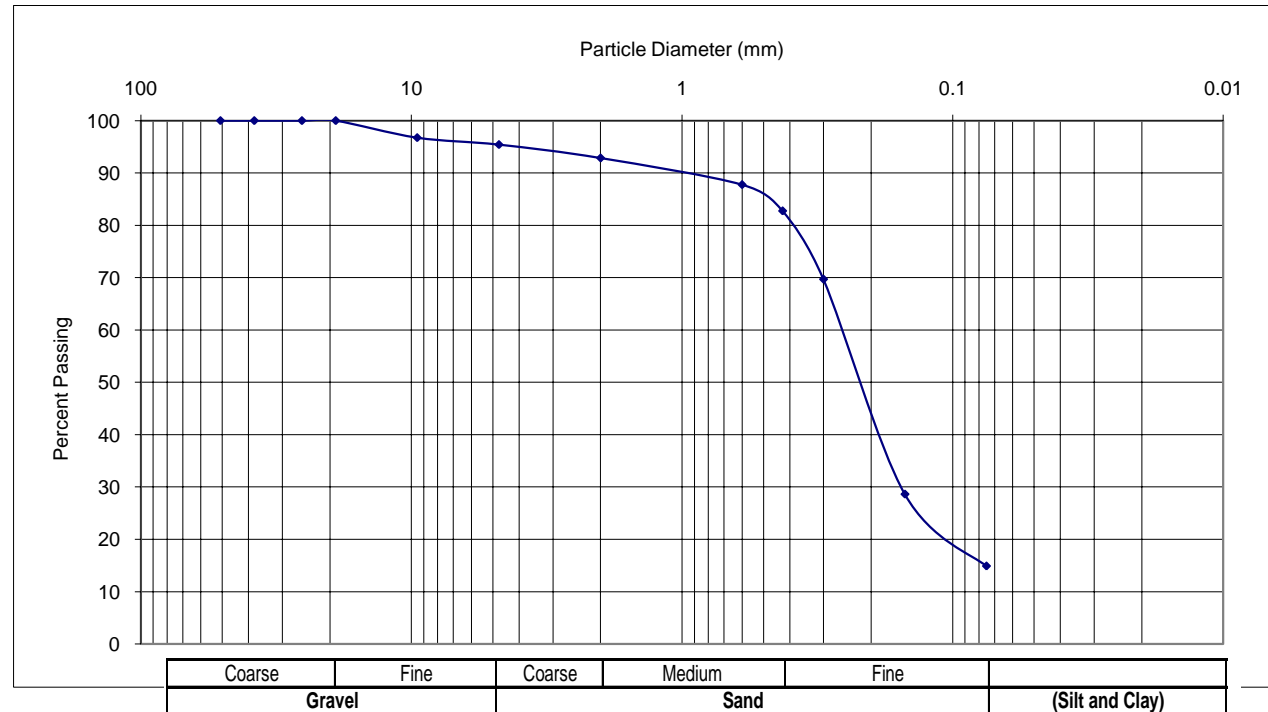
Sieve	Sieve Opening (mm)	Percent Passing (%)
2 in.	50.8	100
1 1/2 in.	38.1	100
1 in.	25.4	100
3/4 in.	19.05	100
3/8 in.	9.525	96.7
#4	4.75	95.4
#10	2	92.9
#30	0.6	87.8
#40	0.425	82.8
#50	0.3	69.7
#100	0.15	28.6
#200	0.075	14.9

Remarks: Gravel 4.6 % Sand 80.5 %
Passing #200 Sieve (Silt & Clay) 14.9 %

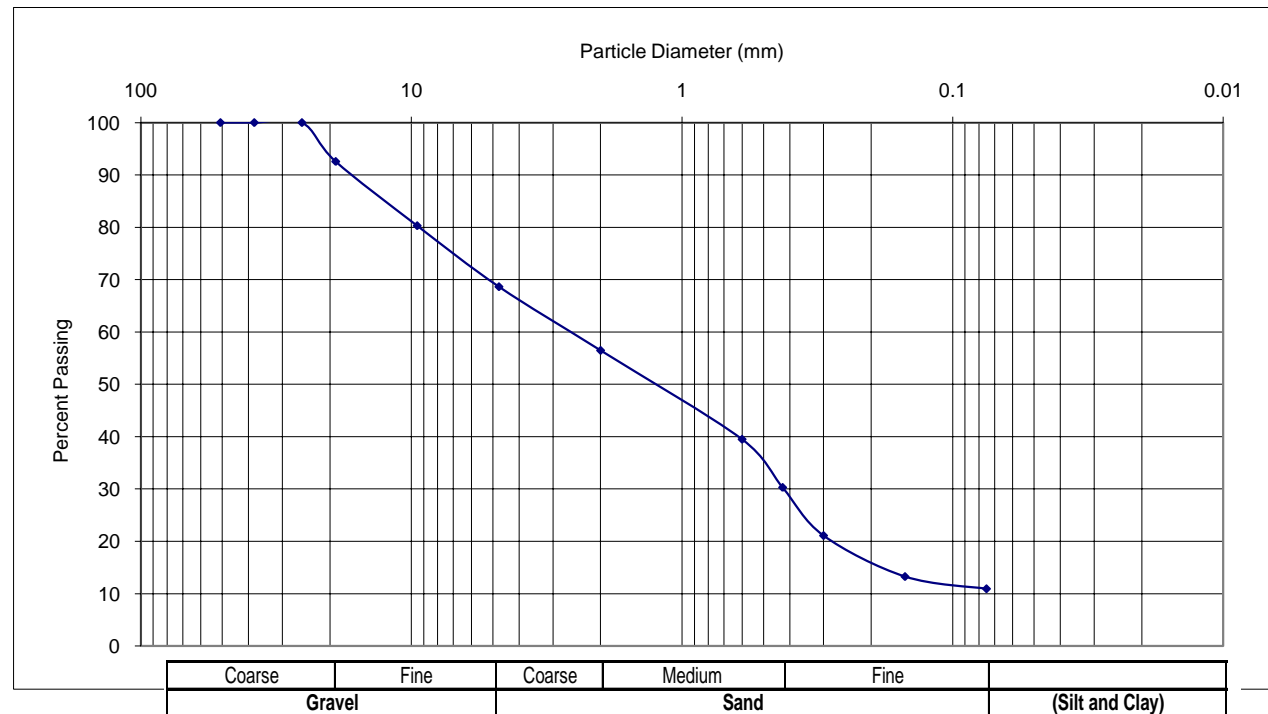
Sieve	Sieve Opening (mm)	Percent Passing (%)
2 in.	50.8	100
1 1/2 in.	38.1	100
1 in.	25.4	100
3/4 in.	19.05	93
3/8 in.	9.525	80.3
#4	4.75	68.6
#10	2	56.5
#30	0.6	39.5
#40	0.425	30.3
#50	0.3	21.1
#100	0.15	13.3
#200	0.075	10.9

Remarks: Gravel 31.4 % Sand 57.7 %
Passing #200 Sieve (Silt & Clay) 10.9 %
